Manhole Inspection Summary

Manhole # S31K__009MH

Insp Date: **3/25/08 1:14 PM**

Location Address: **w. camden**

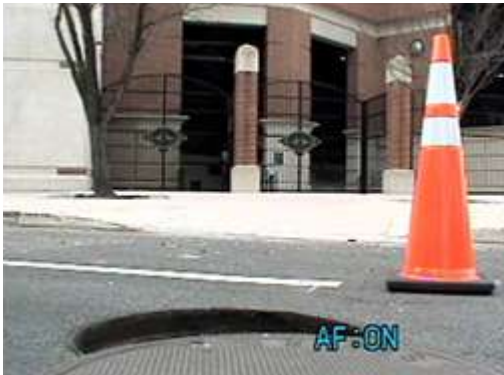
Location View

Comments **Full of debris. Manhole is next to a big construction site.**

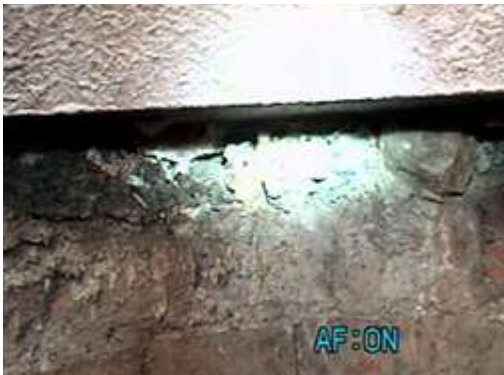
Defect 4

Condition: ☐ Sound ☐ Cracked ☐ Root Intrusion ☐ Loose Brick ☒ **Deteriorated**

frame adj deteriorated

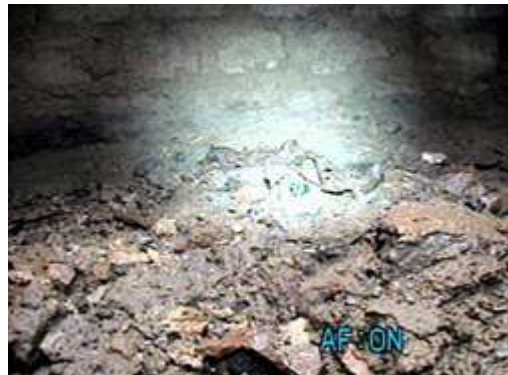
Defect 3

Condition: ☐ Sound ☐ Cracked ☐ Root Intrusion ☐ Deteriorated ☐ Leaks ☒ **Debris**

bench debris

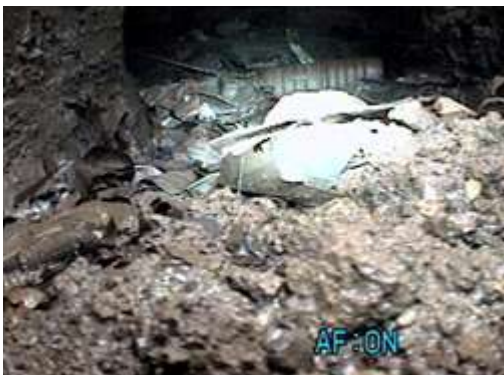
Defect 2

Condition: ☐ Sound ☐ Cracked ☐ Root Intrusion ☐ Deteriorated ☐ Leaks ☒ **Debris**

channel debris

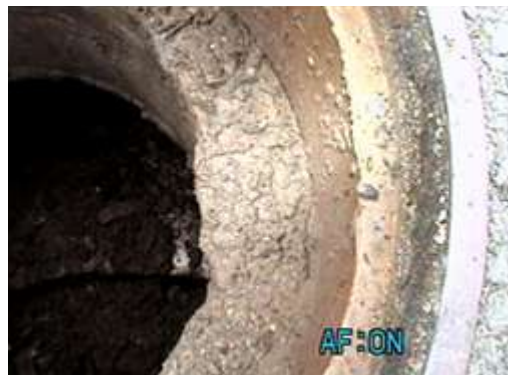
Defect 1

Frame Offset: **2** (in.) Condition: ☒ Sound ☐ Cracked ☐ Leaks

offset

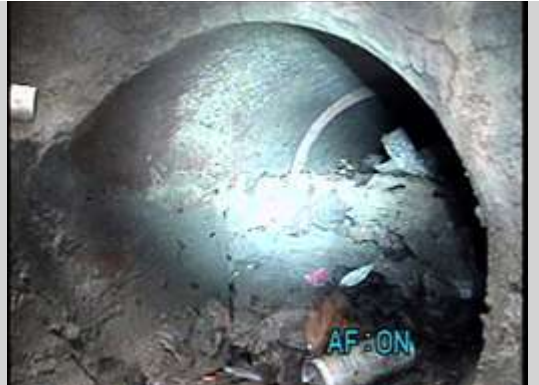
12 O'Clock Outflow

15 in. Circular Gravity Sewer
Pipe Out @ 12 O'Clock

Deposits: ☐ None ☐ Mud ☐ Sludge ☒ **Debris** ☐ Grease

Silt Depth: 10 (in.) Deposits Extent: **Heavy**

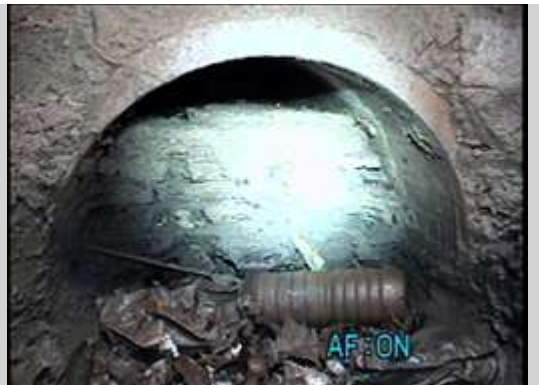
8 O'Clock Inflow

15 in. Circular Gravity Sewer
Pipe In @ 8 O'Clock

Deposits: ☐ None ☐ Mud ☐ Sludge ☒ **Debris** ☐ Grease

Silt Depth: 10 (in.) Deposits Extent: **Heavy**
